Service Bulletin

Bulletin No.: 20-NA-136

Subject: 9T65 Automatic Transmission Replacement Pilot Program (U.S. Only)

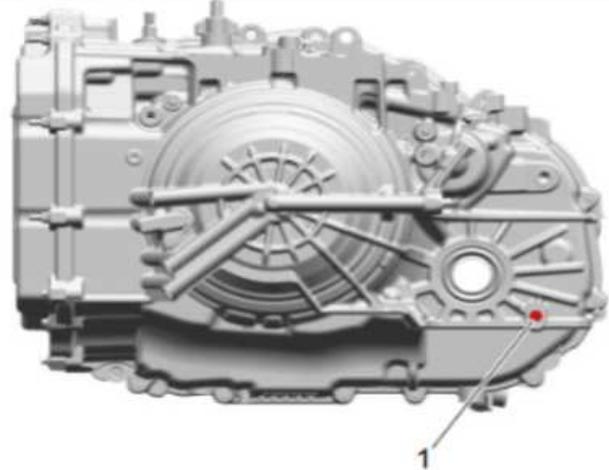
5619626

6. While the vehicle is idling, remove the oil level set plug (1). Allow any fluid to drain:
 - If the fluid is flowing as a steady stream, wait until the fluid begins to drip.

- If no fluid comes out, add fluid until fluid drips out.
7. Record fluid level; overfilled, under-filled, correct on repair order and how much was needed to fill or came out:

- If fluid is overfilled, set correct level and retest.
 - If fluid is under-filled, inspect for external leaks. Refer to *Fluid Leak Diagnosis*.
8. If fluid level is correct, then check condition of the fluid.
